ade 000112  
NRL Memorandum Report 3685

## Fracture Initiation in Irdome Grade $\text{MgF}_2$

R. W. RICE, S. M. MOREY and F. W. FRASER

January 1978

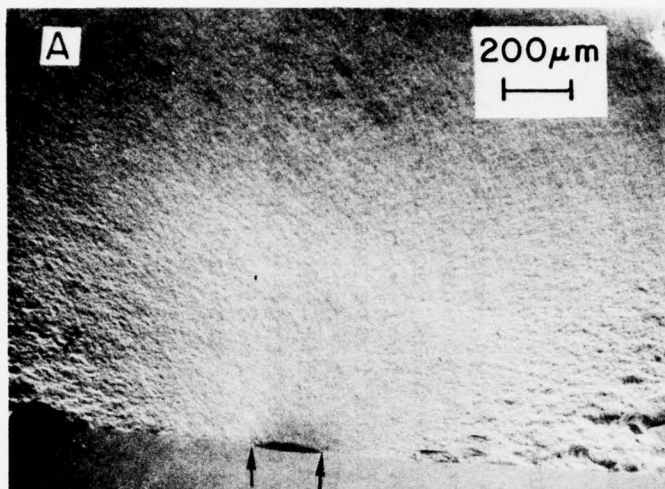
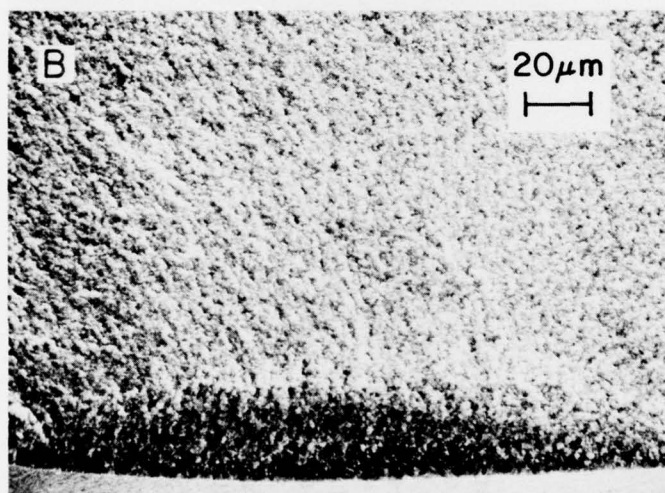
Figure 5

MgF<sub>2</sub> disk failing from a machining flaw. A and B are SEM photos of the actual fracture surface of specimen No. 7 of Table 1 which failed from a surface machining flaw bounded by the arrows in A and shown in higher magnification in B. The elongated shape of this flaw as well as the smooth flaw periphery suggest that this is a flaw from the final stages of finishing the disk, i.e. polishing, rather than a part of coarser flaw left over from earlier grinding.
